Section 6

Structure and Body Condition

Objective:

To ensure the vehicle body is free of protrusions, structurally sound and free from any defects or additional fittings that are likely to increase the risk of bodily injury to any occupant and other road users.

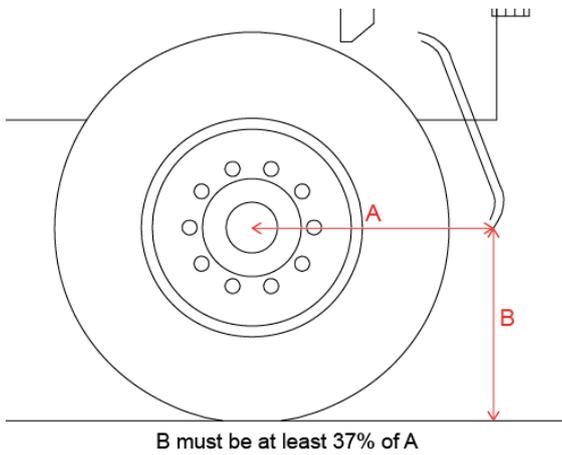
⚠ The height of the mudguard and/or mudflap from the ground need not be less than 230mm, or for a vehicle to be used off-road 300mm.

Figure 6.1 Measuring mudguard/mudflap height

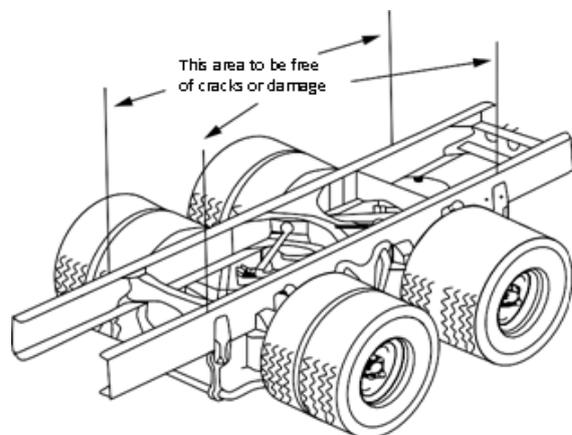
- Any part of the chassis or sub-frame is:
 - cracked
 - distorted
 - sagging
 - loose, broken, or
 - affected by extensive or advanced rust.

Figure 6.2 Example of critical structural components

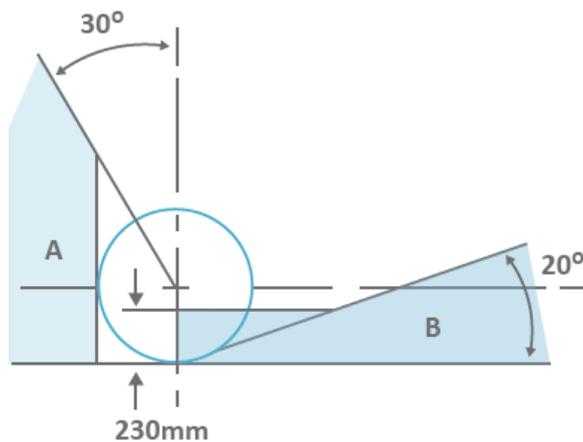
Figure 6.2 Mudguard and mudflap protection area

Mudguards and mudflaps must be capable of deflecting downwards any mud, water, stones or any other substance thrown upward by the rotation of the wheels. As outlined in Figure 6.2, mudguards must be fitted to the vehicle in such a manner that provides continuous protection between a point in area A and a point in area B and must be provided for the overall tyre width of all tyres.

Notwithstanding the requirements specified above, the mudguard, including a mudflap (if fitted), does not need to come any lower than 230mm from the ground, or for an off-road vehicle, 300mm.

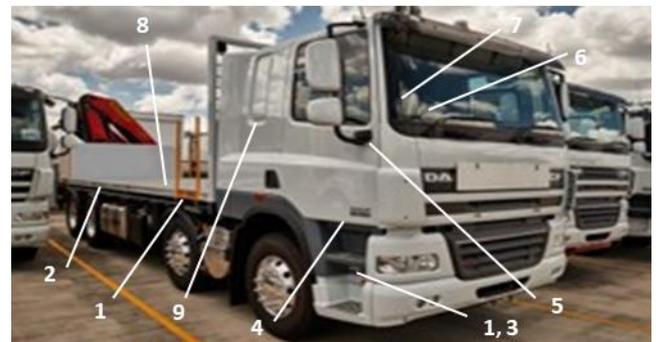
Typical primary structure components

1. Main structural members such as sub-frames and chassis rails
2. Suspension mountings and parts
3. Steering component mounting points
4. Door sills and pillars
5. Door hinges and latch mounting points
6. Seat anchorage points
7. Seatbelt anchorage points
8. All floor panels
9. Bulkheads.

Figure 6.3 Primary structure components

This category includes any structure or component which, if it collapsed, would make the vehicle uncontrollable or would considerably reduce occupant safety in a crash. Examples of components in this category are illustrated below.

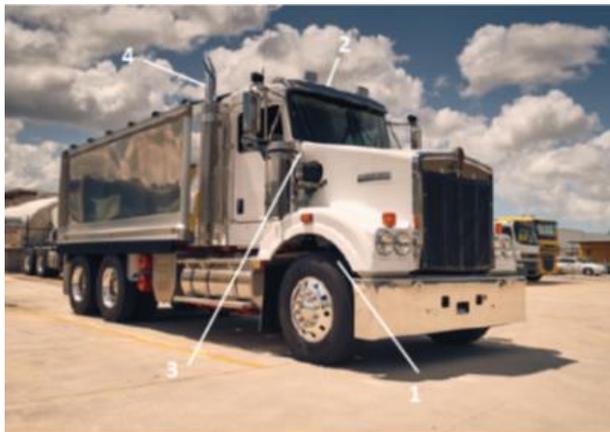
Typical secondary structure components

1. Mudguards or fenders
2. Roof
3. Bonnet and doors (areas within 100mm of mounting and locking points are primary structures and must be free of advanced or extensive rust)
4. Exhaust system.

Figure 6.4 Secondary structure components

because of its sharp edges or because exhaust fumes can get into the vehicle. In such cases, extensive rust must therefore be rejected. The illustration below shows examples covered by this category.
