# Investigations outcome 005

### **Improvement Notice**

Incident date: 31 May 2023

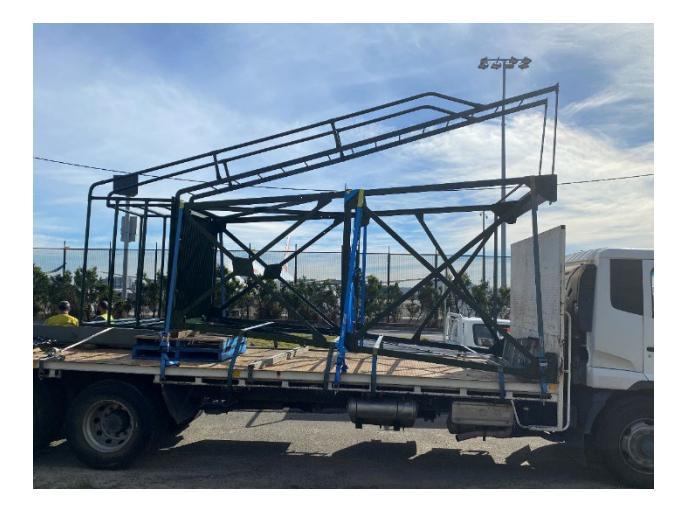
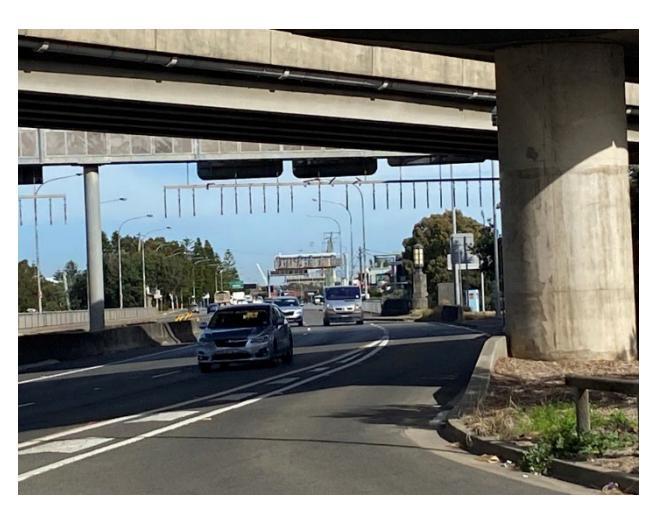
The vehicle was loaded with portable aeroplane stairs and had struck the Over Height Vehicle Detection System.

Lane 1 was closed for approximately 30 minutes while the height of the vehicle and load was checked. A measurement of 4.585 metres was obtained.

Police issued a Penalty Infringement Notice to the driver, and NHVR Safety and Compliance Officers (SCOs) issued a direction to reduce the height to 4.3 metres.
